Manhole Inspection Summary

Manhole # S45C2_015MH

Location Address: **1501 Spruce St** Cross Street: **Fairhaven Ave.**

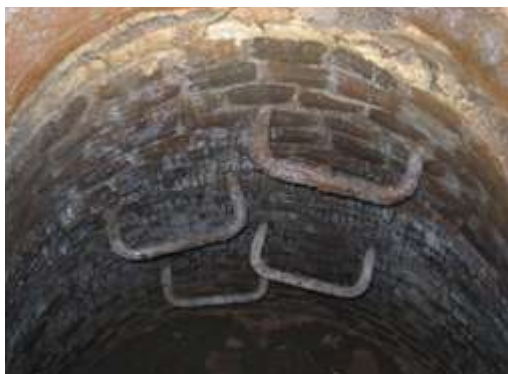
Steps Count: **4** Missing: **0** ☐ Corroded

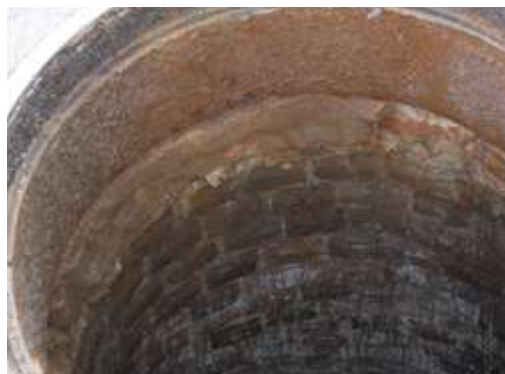
Defect 1

Chimney / Frame Adjustment ☒ Exists Material: **Brick** ☐ Parged Height: **0** (in.)
Condition: ☒ Sound ☐ Cracked ☐ Root Intrusion ☐ Loose Brick ☐ Deteriorated
Infiltration: ☐ None ☐ Joint ☐ Cracks ☐ Mortar ☐ Roots ☒ **Wall**

Barrel Material: **Brick** ☐ Parged
Shape: **Circular** Diameter: **42** (in.) Length: (in.)
Condition: ☒ Sound ☐ Cracked ☐ Root Intrusion ☐ Loose Brick ☐ Deteriorated
Infiltration: ☐ None ☐ Joint ☐ Cracks ☐ Mortar ☐ Roots ☒ **Wall**

Infiltration

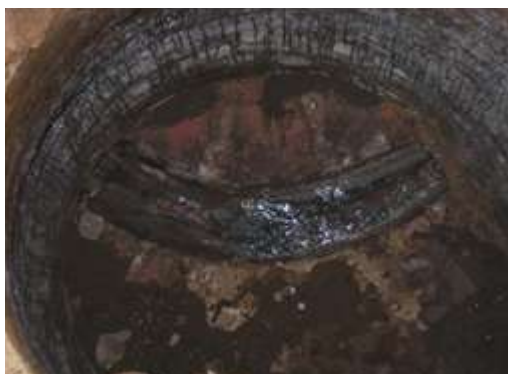
Defect 2

Debris

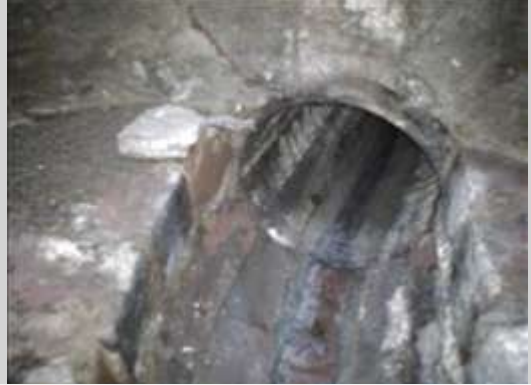
12 O'Clock Outflow

8 in. Circular Gravity Sewer
Pipe Out @ 12 O'Clock

Pipe Height: **7.2** (in.) Rod and Bar (Angled)
Pipe Material: **Clay** ☐ Pipe Lined
Invert Depth: **8.37** (ft.) Flow Characteristics: **Fast**
Deposits: ☒ None ☐ Mud ☐ Sludge ☐ Debris ☐ Grease
Silt Depth: (in.) Deposits Extent:
Infiltration: **None** Pipe Seal Cond: **Sound**

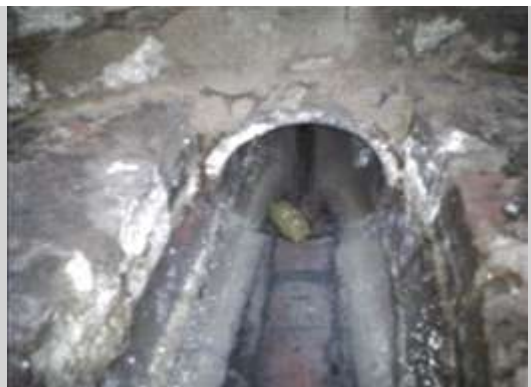
4 O'Clock Inflow

6 in. Circular Service Sewer
Pipe In @ 4 O'Clock

Pipe Height: **7.2** (in.) Rod and Bar (Angled)
Pipe Material: **Clay** ☐ Pipe Lined
Invert Depth: **8.24** (ft.) Flow Characteristics: **Fast**
Deposits: ☒ None ☐ Mud ☐ Sludge ☐ Debris ☐ Grease
Silt Depth: (in.) Deposits Extent:
Infiltration: **None** Pipe Seal Cond: **Sound**
